RUINS, RUBBISH DUMPS AND ENCROACHMENT: RESURVEYING LATE ANTIQUE OSTIA

Axel Gering

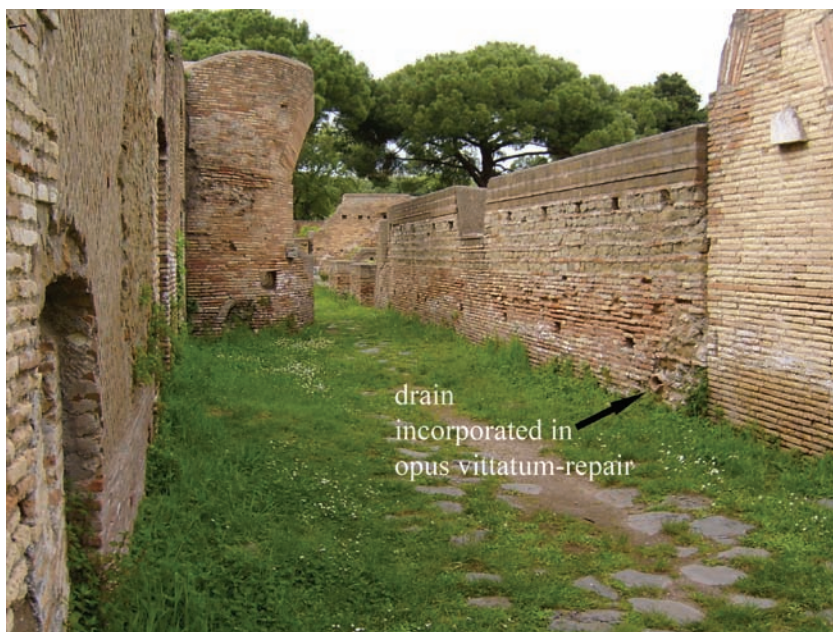
Fig. 3. Caseggiato del Sole with a closing wall and drain.

The 'Caseggiato del Sole' (fig. 3, fig. 11: R2d) is, in its present form, a ruin. It was originally a multiple-storey-building, but only the ground

The pieces of evidence for this later use are: late drains coming from the upper floors; the very thick blocking wall along the street (fig. 3), which can be explained by it supporting more upper floors; and a gap for a threshold for a new door about +1.00m above street level, which was

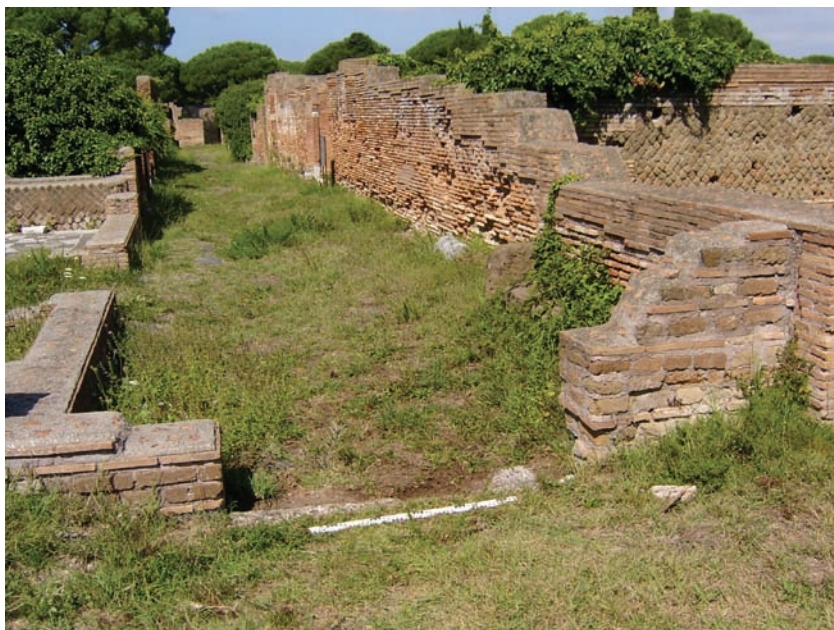
Fig. 4. Blocked street with a door in the context of the late houses V ii and iii.

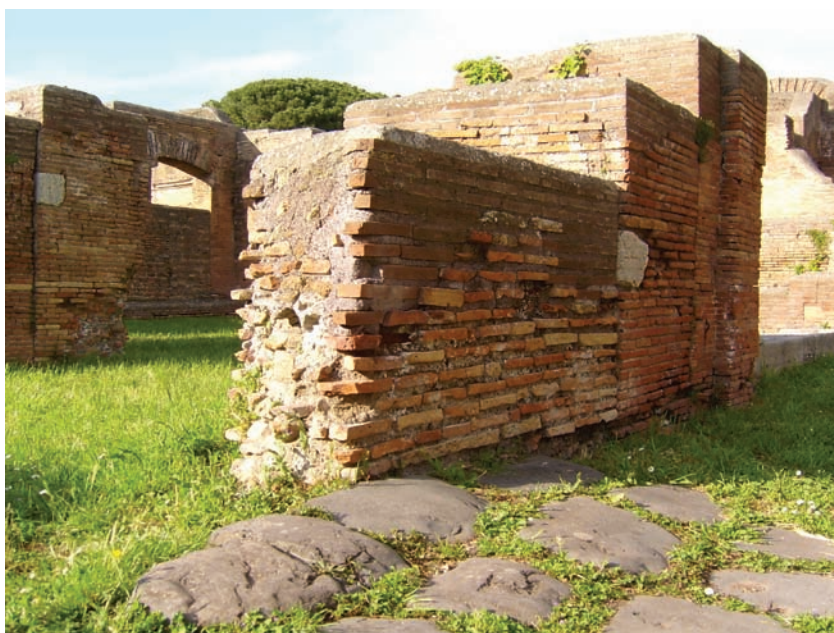
Fig. 5. Blocked cardo north of Capitolium.

and different rises in ground level (for example fig. 2: 10=fig. 5.: blocking of all side-doors linked to these streets to close off the northern cardo).

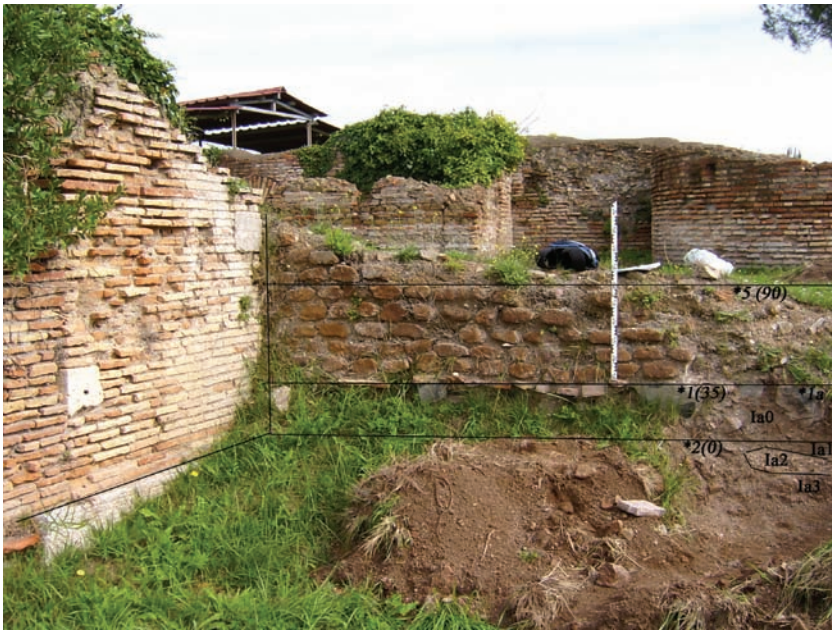
Fig. 6. Blocked sidewalk of Via della Foce.

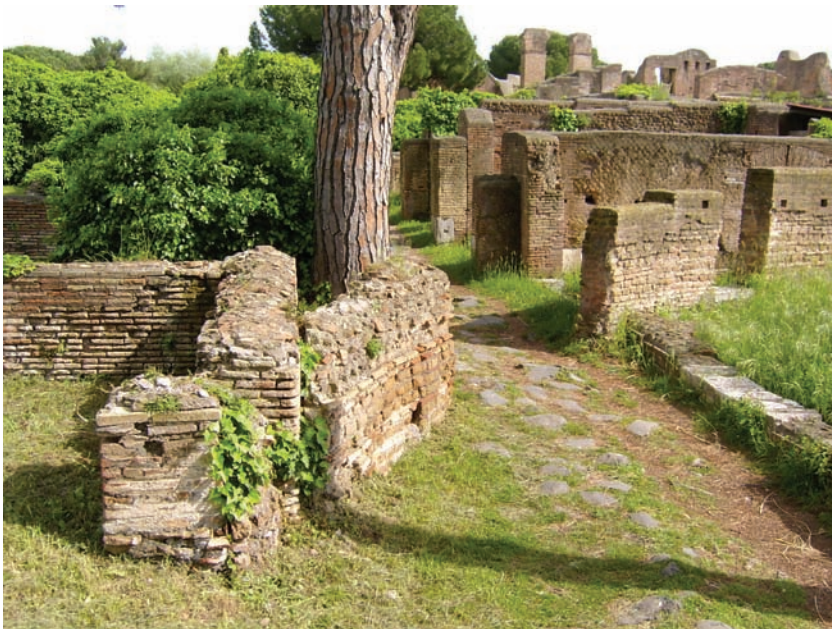
Fig. 7. Blocked *semita Horreorum* by back wall of *exedra*.

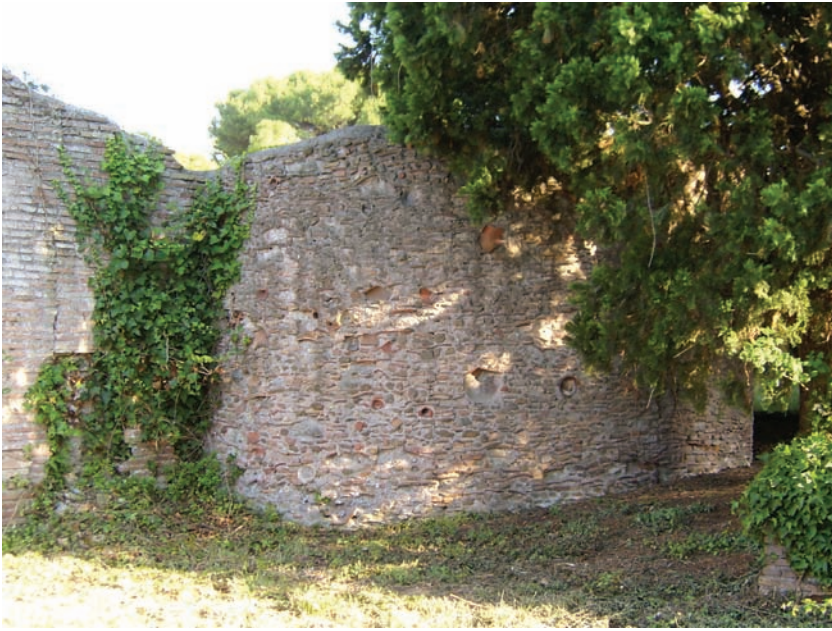
Fig. 10. Blocked market street by apse S4a of Domus dei Tigriniani.

A good example of this dating technique can be seen with the apse of a nymphaeum inside the House of the Tigriniani (fig. 9: S4a. fig. 10 from its rear),¹² which served to block two former market streets. Here

we have lots of dating evidence for the house (capitals, inscriptions), and supplementary dating evidence from the reused ceramics (instead of bricks) used in the facing of the walls of the apse (fig. 10). Also, the blocking on the other side of the market area was to close off the same streets (fig. 9: S4b). Though most of the individual building activities are not very well-preserved or datable in isolation, they can be understood together as a single localised functional change in the urban landscape.

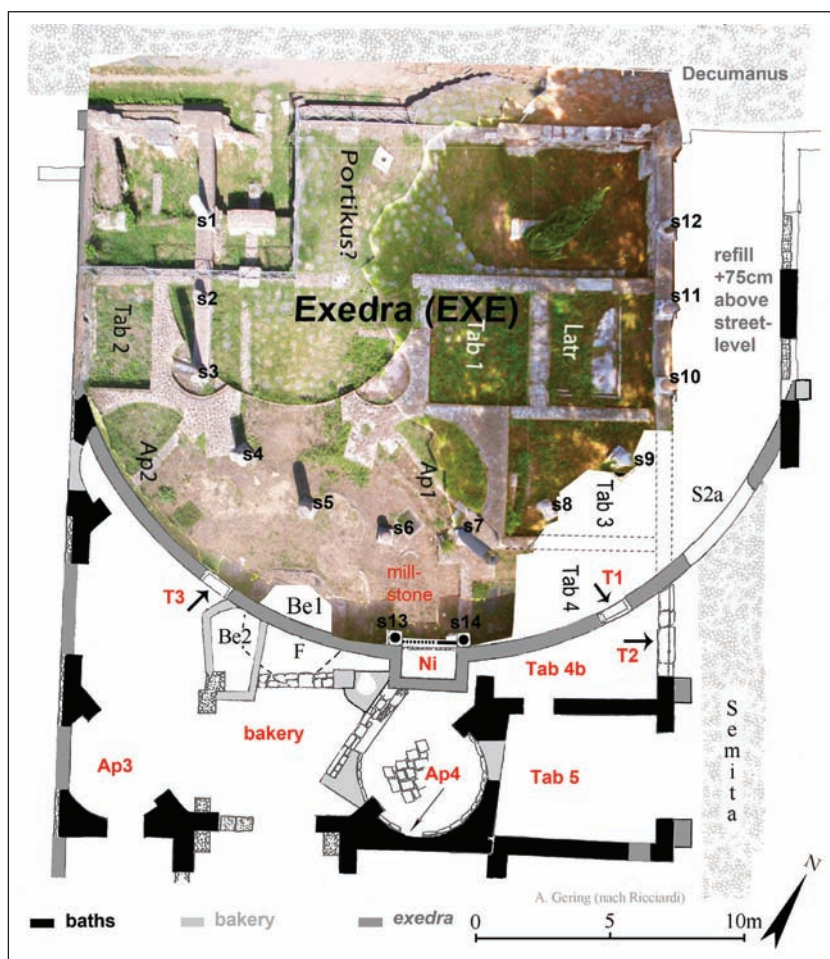
Fig. 12. Plan of *exedra* and earlier structures.

The first building phase of the *exedra* can be dated to after the demolition of its structural predecessors on the site: a monumental entrance to a bath building of the 2nd c., characterised by four apses inside a quadratic room and a large entrance-hemicycle in the direction of the Decumanus (fig. 12: Ap1–4, with Ap4 reused as a baking-oven). These baths were originally much bigger (fig. 12: black walls of an open structure to the south

and west) and were surrounded on three sides with shops. Their facade was still standing while the whole area inside was reused as a mill-bakery before the *exedra*-back-wall was built, but a reduced bakery could have been still in use even after this, with an older water-basin incorporated into the later *exedra*-back-wall (fig. 12: Be2). During the 4th c. a toilet with a pavement of reused marble slabs was installed in the corner-shop of the facade at a higher level (fig. 12: *Latr.* fig. 13).¹⁵ The toilet's spolia pavement

A new trench by the author, inside the central octagonal water-basin of the baths (fig. 12: *Be1*), was opened in 2005 to look for dating evidence underneath the later back wall of the *exedra*. The excavated material showed a unique filling process for the *exedra*'s foundation pit, with building debris from burned and collapsed marble architecture present. Similar fill levels were excavated by Calza, and consisted of finds from this area which cannot be dated before the 4th c., using stylistic comparisons of their decoration. Final proof for this dating was provided by an inscription of Vincentius Ragonius Celsus (*praefectus annonae* in A.D. 385–89), which was found here by Calza and had obviously been reused to raise the *exedra*'s floor-level (fig. 17), but had originally come from the Forum Baths where Calza had returned it, along with other fragments, shortly after its discovery.¹⁶ The *exedra*, therefore, is unlikely to have been constructed

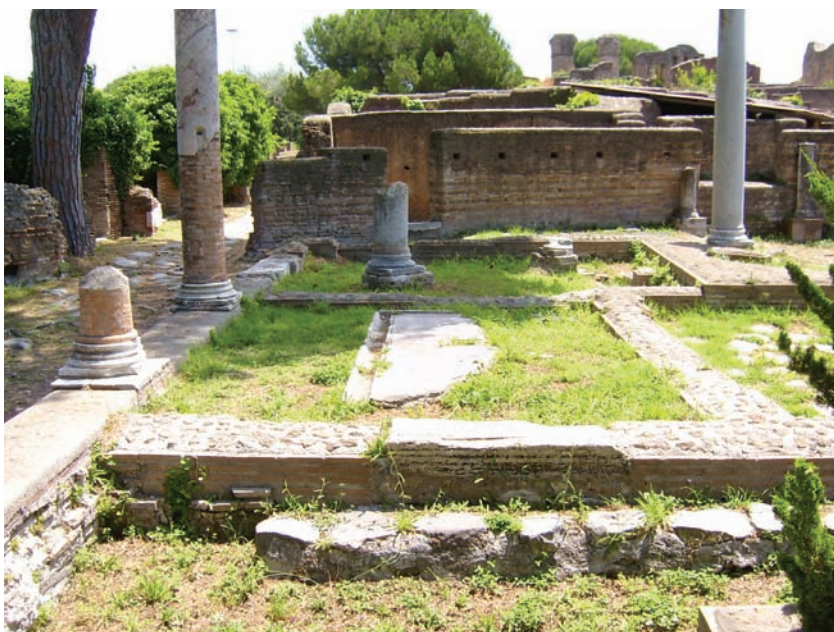
Fig. 13. *Exedra* seen from the Decumanus.

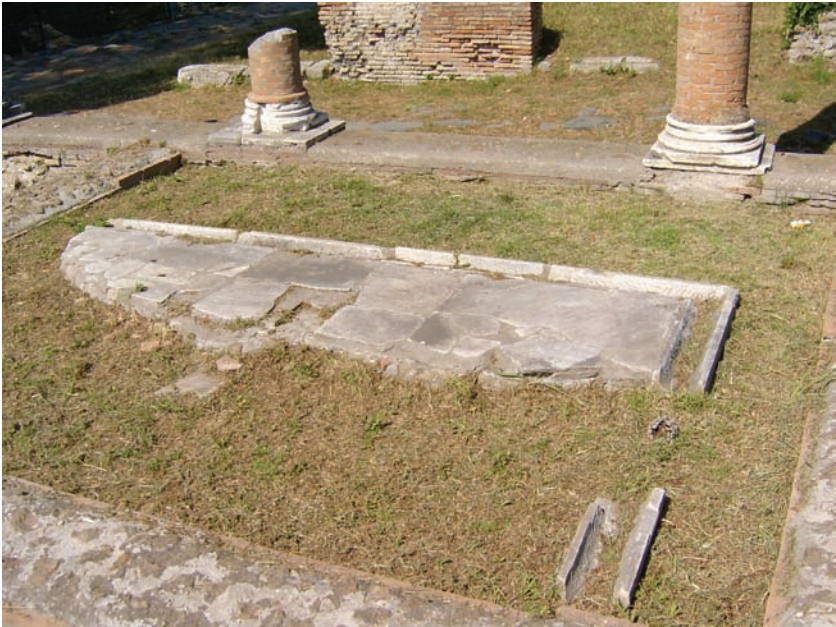
Fig. 14. *Exedra*: marble floor with spolia.

consisted of roof-tiles and the rooftop of a marble temple, reused as a water channel (fig. 14.15). The reused sets of spolia and the layout of the slabs is very similar to another toilet ('forica', fig. 11: *L1*), dated by TPQ of a Constantinian inscription reused in its pavement (fig. 16).

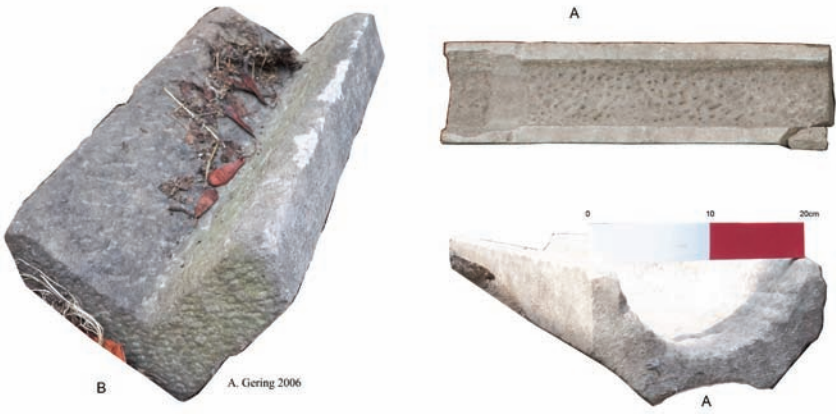
Fig. 15. *Exedra*: temple rooftops reused for drains.

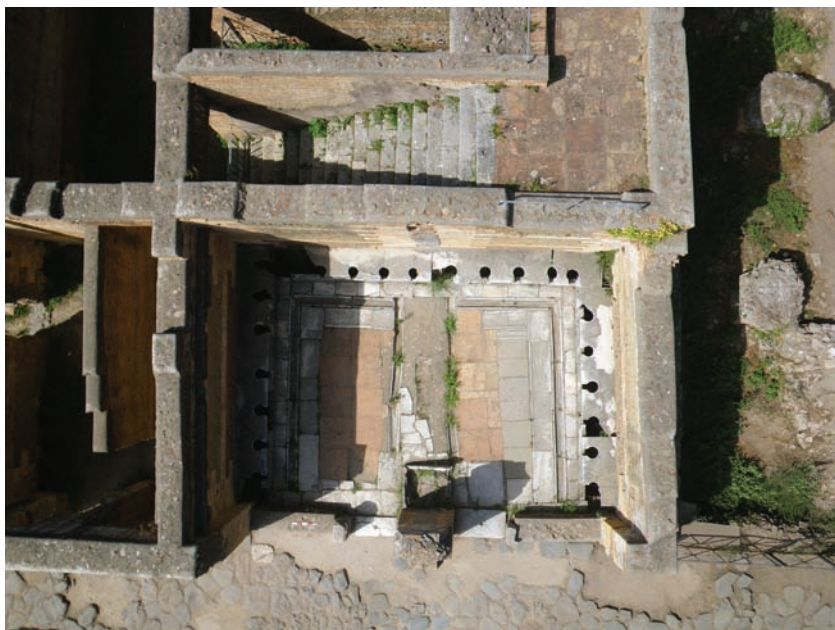
Fig. 16. Toilet L1 in the Via della Forica.

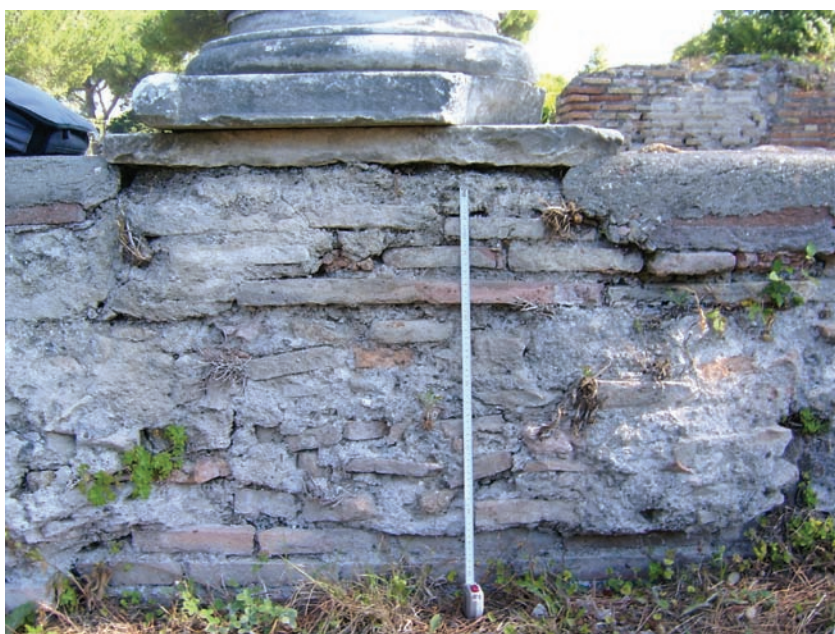
Fig. 17. *Exedra*-columns: foundation-wall with building-rubble.

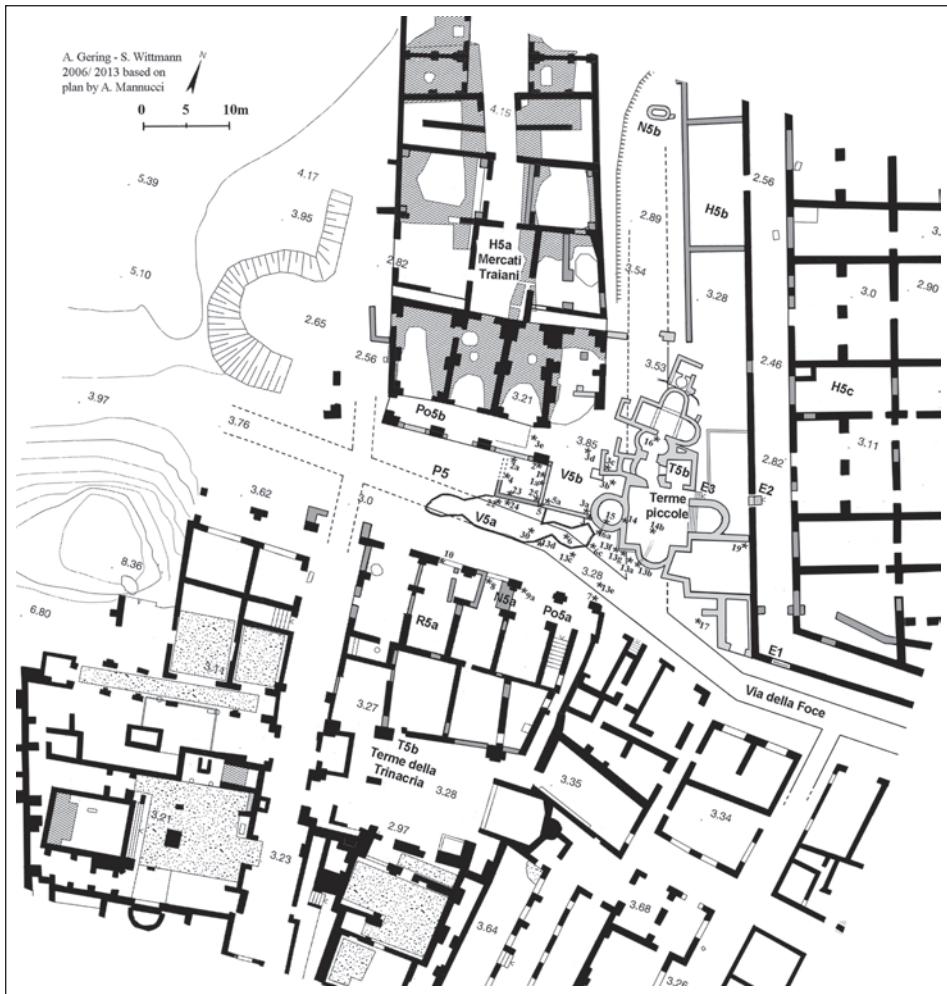
Fig. 20. Plan of the Terme piccole and the collapsed facade.

While the collapsed facade, probably from the structure opposite, fell directly onto the street paving, the lowest part of the foundations of the baths were in fact constructed at a substantially higher level, some +35 to +40 cm above the street (figs. 19, 20). Part of the fill between the fallen *insula* facade and the new foundation of the Terme piccole contained oil lamps of Hayes I type and ceramics which date from the middle of the 4th c. onwards. The wall decoration of the baths has no specific dating relevance as it seems to have consisted mainly of marble spolia; many inscribed or worked slabs were found inside the baths, as well as imprints in the mortar. The baths and their adjoining 'Palaestra' garden with a small fountain, and the beginning of the rear wall (fig. 20: N5b), were perhaps connected to a still unexcavated house to the north.

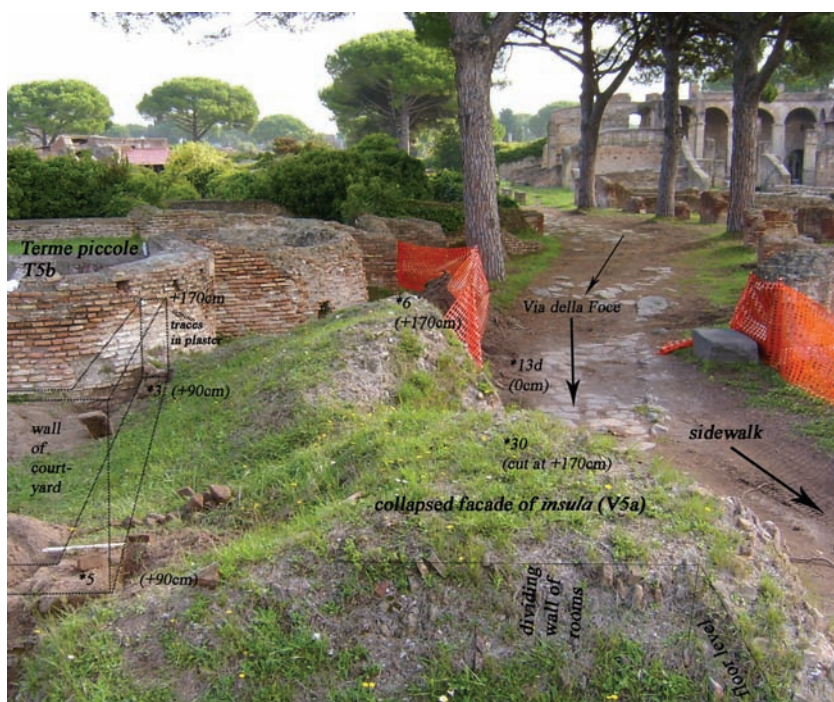
Fig. 21. Via della Foce blocked by collapsed facade.

(fig. 21: traces in plaster). This wall then had obviously fully covered the ruin of the fallen facade.

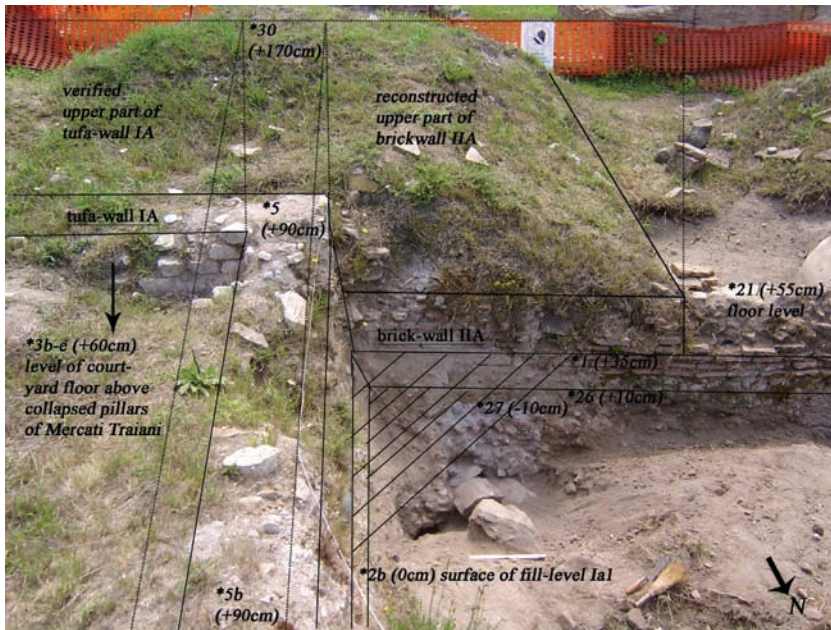
Fig. 22. Collapsed facade seen from courtyard of baths.

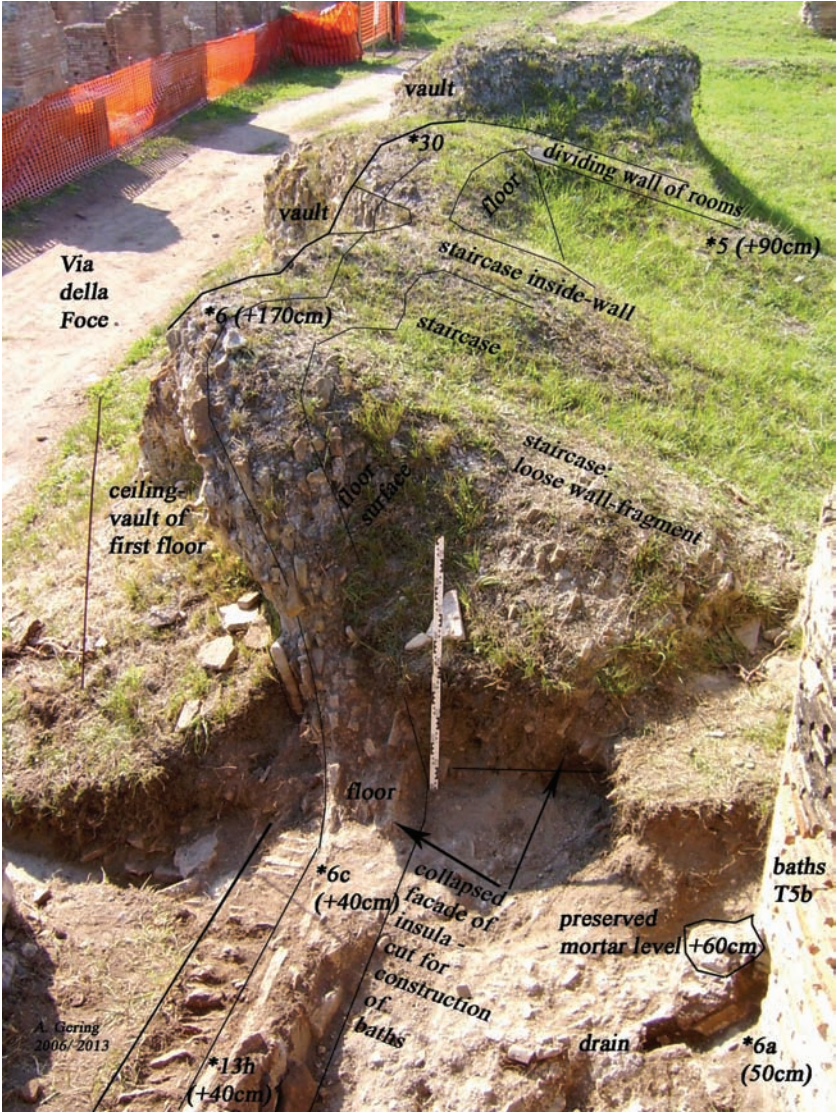
Fig. 23. Collapsed facade seen from east.

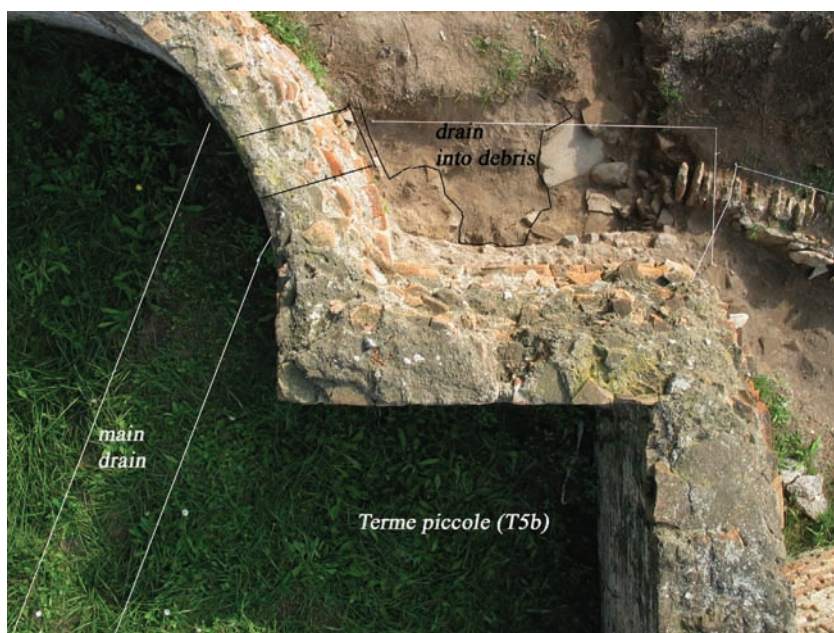
Fig. 24. Terme piccole: drains into building-rubble.

The Terme piccole's wastewater led straight into this artificial fill-layer (fig. 24) immediately adjoining the fallen facade; the builders did not try to reach or repair the communal water system underneath the street pavement again. However, the activity here was not a city-wide phenomenon yet; the Forum Baths in the city centre showed much later sewer repairs, using late antique amphorae.²³ In western Ostia though, the sewer system seems to have been abandoned earlier, probably in connection with the massive *insula* collapse onto the street.

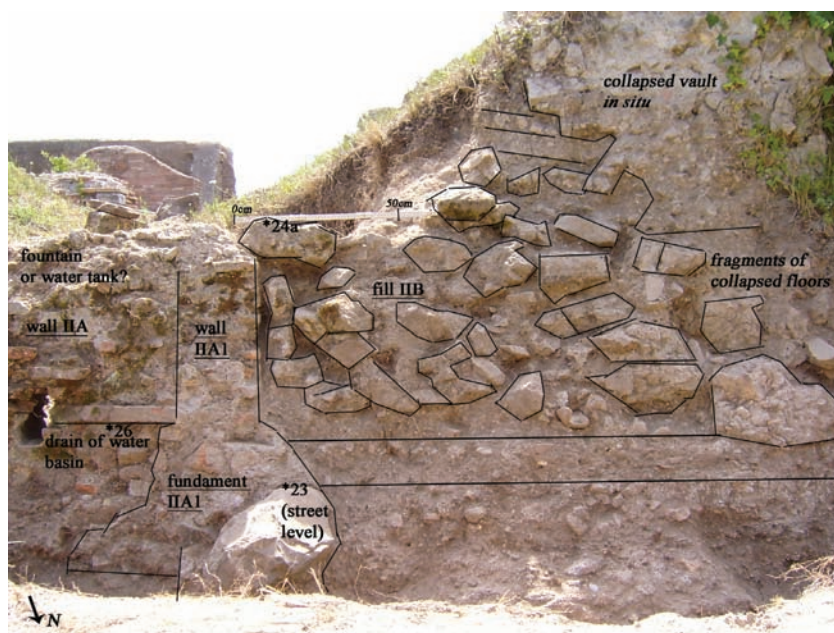
Fig. 25. Collapsed facade seen from the north.

The space between the fountain, or water tank, and the fallen *insula* facade was filled with random fragments of collapsed floors (fig. 25: fill II B). The filling material II B, which was used to create a solid foundation next to the water tank II A, contained rubbish and a broken column, but also coins of Valens (fig. 19). This dating evidence from inside the foundations suggests the final 'cleaning up' and building work in and around the facade ruin did not start before the second half of the 4th c. Several of the walls here show clear sequences and can give us a relative chronology of the events that took place in the area:
