Marble recycling-workshops nearby the Temple of Roma and Augustus: An interim report of the Ostia-Forum-Project's working campaigns in 2013 and 2014

Axel GERING

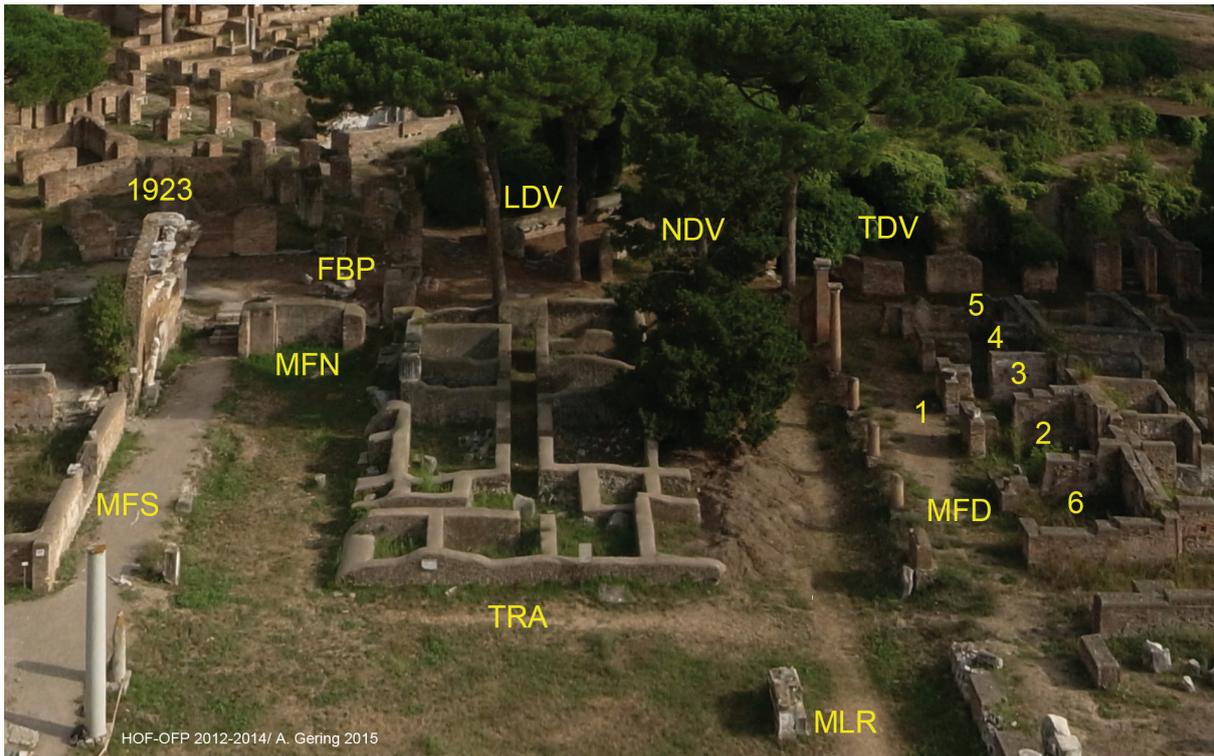
Fig. 1. View to the south part of the Forum of Ostia with the central Temple of Roma and Augustus (TRA) and the Portico MFD with marble recycling industries in the rooms 2-6.

After having finished the excavation of the Forum's portico pavements from 2010 to 2012, the working campaigns 2013 and 2014 of the Ostia-Forum-Project (OFP) were focused on the southwest-corner of the Forum (fig. 1), a "missing link" in our project dedicated to the whole Forum¹.

The whole area around the Temple of Roma and Augustus (TRA, fig. 1) consisted of piles or deposits of mixed and properly sorted recycling materials, ranging from columns and bigger statue fragments to piles of extremely fragmented coloured marbles and stucco-ceiling fragments. The floor of the portico MFD is a mixture of marble-cut-offs, characteristic for artisans' marble-workshops until today, which had been reused as filling-material in the latest concrete floor.

The former shop doors of MFD (fig. 1: rooms 3-5, 6) had been closed by secondary walls. These walls had been almost completely removed by Guido Calza during the excavation in 1923, only some minimal traces of their foundation survived and were drawn in 2013 by our team.

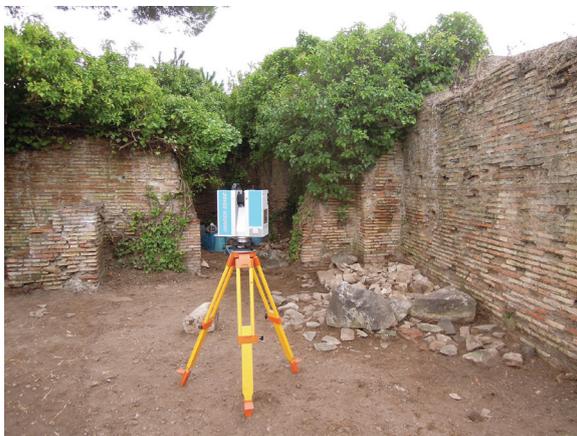
Fig. 2. View into the corner shop TDV with the remains of a huge marble pile after surface-cleaning.

One of these deposits was still covered with earth inside a shop at the corner of the Via del Tempio rotondo and the southern Cardo. This area next to the famous "ninfeo della Venere" (NDV) was named "Taberna della Venere" (TDV, fig. 1).

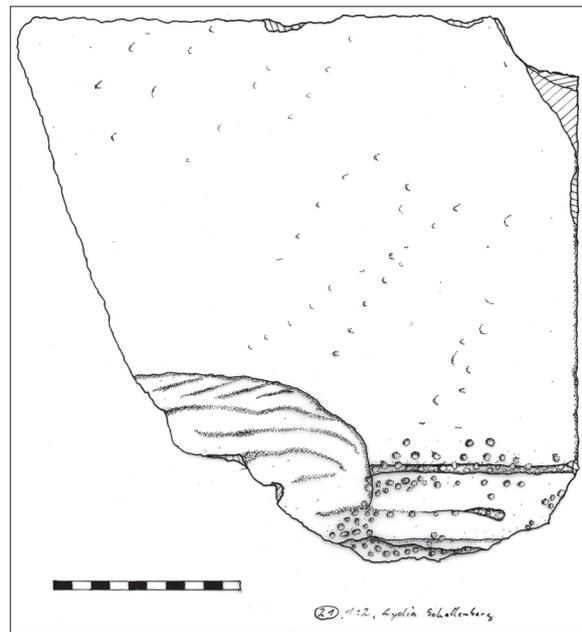
Fig. 3. A cut out statue-tand. Drawing by Felix Huelsebeck.

The main question: "ancient or not" could also be answered by analyzing the marble finds individually with all kinds of available methods. By examining the surface with special photographical techniques focusing on the stone structure, and by drawing each fragment by hand in a careful way, we found clear evidence showing traces of deliberate cutting with a big chisel, which happened before erosion took place (fig. 3: the chisel lines in the position of a former statue foot lay underneath the rain erosion).

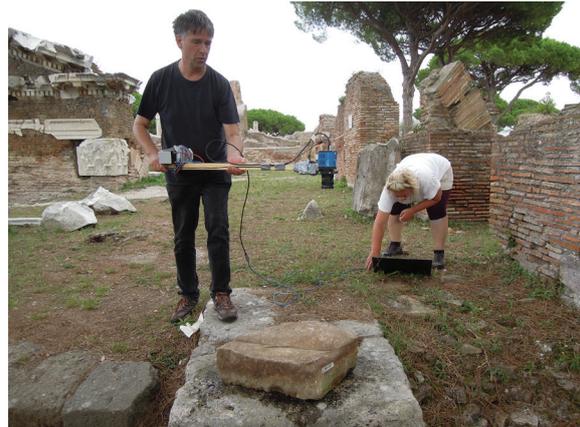
Fig. 4. Find CAW 1 with depiction of a fish-tail in process of 3-D-documentation.

Beside all initial doubts regarding its antique origin, we documented the pile with maximum care and all available modern technology. A new feature of the 2014 campaign was the prototype of a photographic sensor, which was developed for biological and medical research in Bavarian laboratories (fig. 4). The big advantage of this machine was its speed. We were able to take the huge number of pictures (which is necessary to create high-resolution 3-D-point-clouds of complex individual finds) in a very limited time by "making a movie".

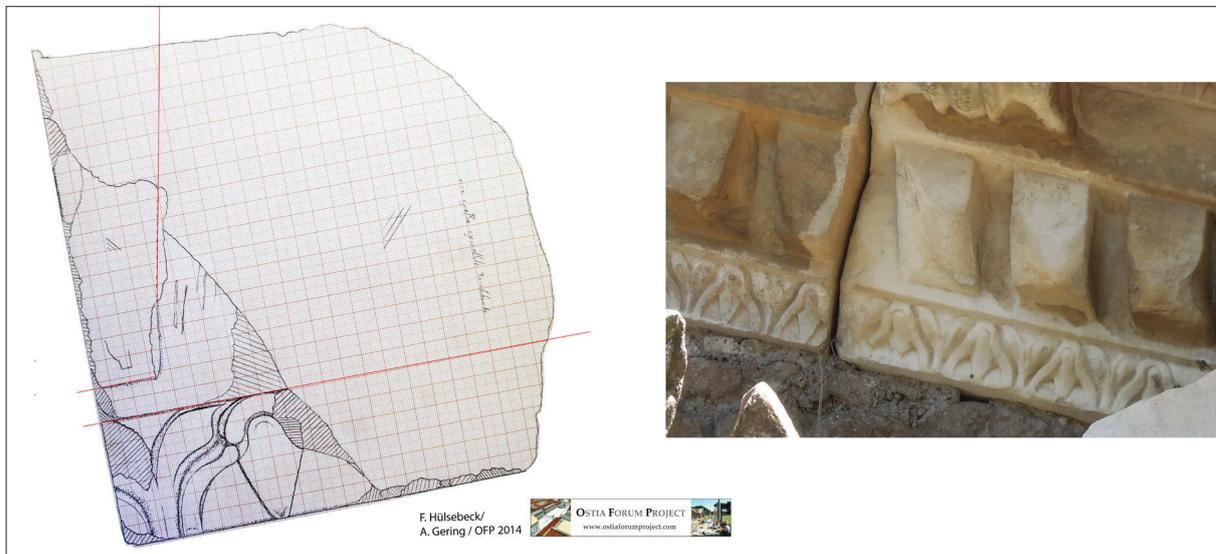
Fig. 5. "Zahnschnitt" from front pediment of the Temple of Roma and Augustus (TRA). <1/2p>

A main part of the marble-finds showed architectural decoration of Augustan style. The first fragment we have found is characterized by an angle of 22° of the "Zahnschnitt" in relation to the rest of the ornament which is identical with the angle of the pediment of the Roma- and Augustus temple (fig. 5), some other fragments came from the temple-pediment itself.

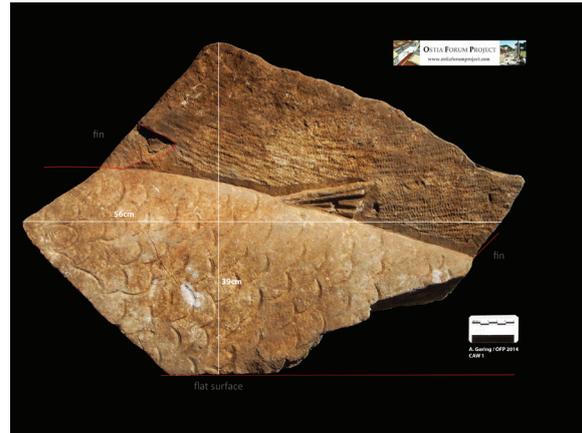
Fig. 6. Fragment CAW 1 of a monumental Fish-tail as part of a Capricorn.

fits directly to the preserved “Zahnschnitt” in the left part of the restored pediment (fig. 6: A): Why was this fragment not used for the pediment-reconstruction of 1924? Or was this material not visible to the former excavators, because it had been buried underneath a cover of low-value fragments of “excavation rubbish”?

One fragment from a nearby marble-deposit (CAW) showed a fish-tail (fig. 6), which could be reconstructed as part of a Triton or – due to the unusual straight proportions for a Triton’s body – more probable as a Capricorn.

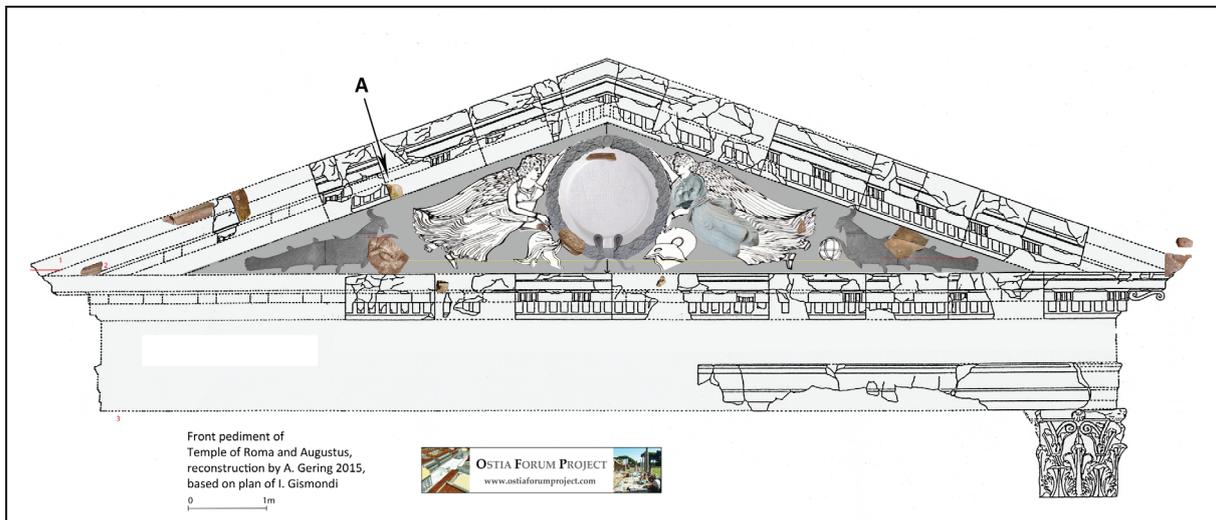
Fig. 7. The temple front with old and new finds included: reconstruction as work-in-progress.

types of decoration, some thicker slabs showed the typical features of isodomic wall-imitation outside. Some columns, capitals or pediment- and roof elements were extremely fragmented, but still easy to be classified due to the reconstructed architectural display of all major finds until 1923 (fig. 1: 1923, fig. 7).

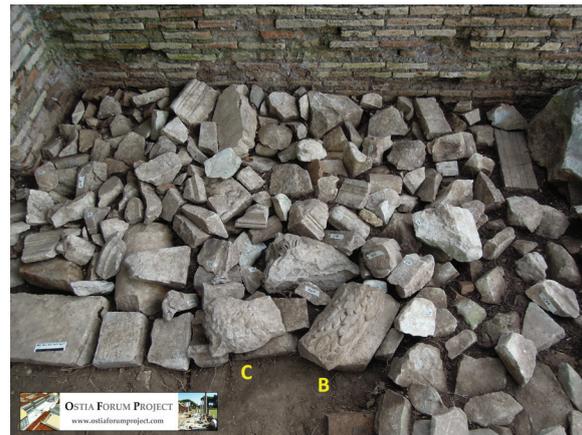
Fig. 8. Marble pile in TDV with wreast-fragment of oak-leafs (B: full diameter reconstructed 160 cm).

The remains from the 1920ies excavations of the temple-pediment were analyzed in detail by the excellent study of R. Geremia-Nucci³. We could supplement her reconstruction by the heraldic Capricorns in the pediment-corners holding the globe and a new – and stylistically better fitting – wreath (fig. 8: B) in the middle which once surrounded a *clipeus virtutis*⁴. The pediment shows the full range of Augustus' concept of power and "propaganda" with a direct link to the emperor's chosen sign of the zodiac.

artisan's workshop, verified by random chisel marks or very uneven lines. We also found parts of a half worked marble water basin, which occurs frequently in the context of early Christian churches (fig. 8: C, earlier examples of this type exist, but are very rare).

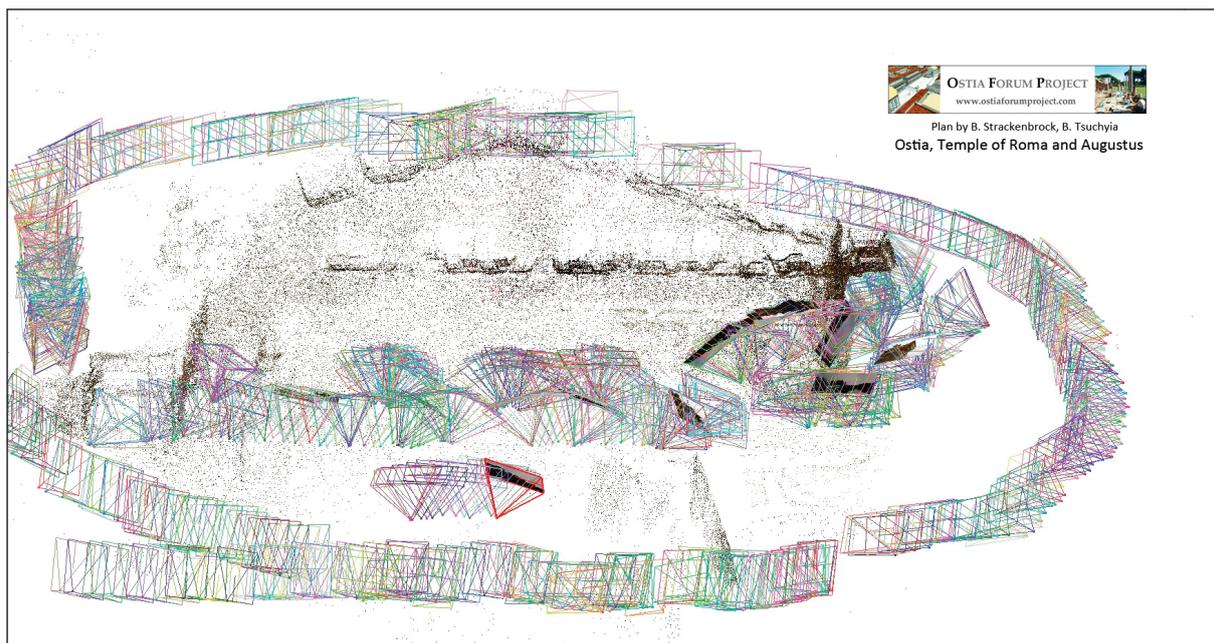
Fig. 9. 3-D-processing of the temple pediment by members of the German Aerospace (DLR).

Fundamental for the 3-D-reconstruction-modell, which will help us to fit in more pieces, is the pointcloud of G. Calza's pediment (fig. 9). Visible are also the various camera positions, which were used to get the pediment photographed from all possible angles with the necessary overlapping for 3-D--models.

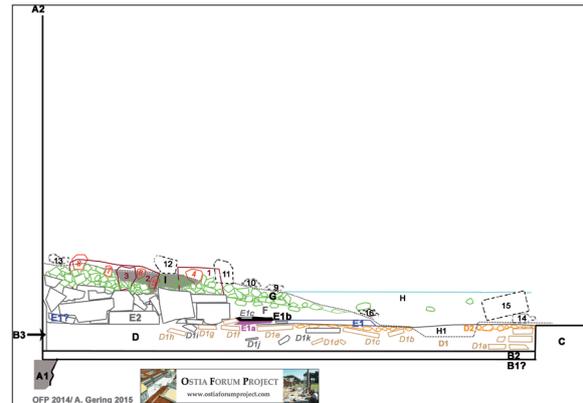
Fig. 10. The marble deposit in TDV and its stratigraphy (based on archeological surface cleaning and documentation 2012/2014).
